Faculty of Earth Sciences and Spatial Management, Maria Curie-Skłodowska University

The mechanism and stages of development of a field road gully in relation to changes in the surrounding land relief

Keywords: road gully, loess areas, soil erosion, Lublin Upland

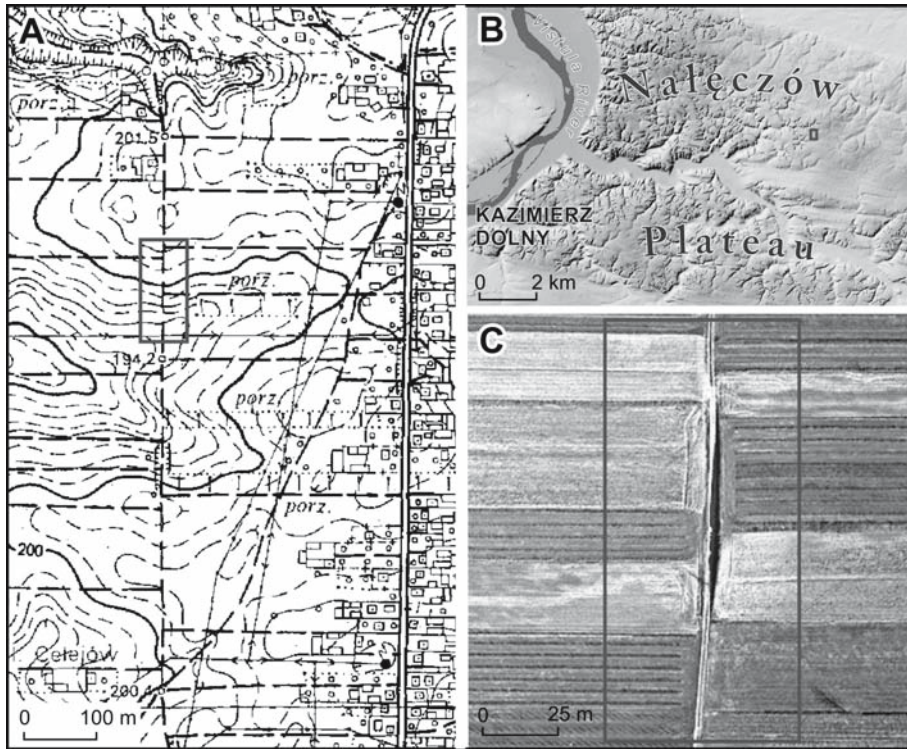
Fig. 1. Location of the study polygon (following Rodzik et al. 2010, modified): A – on the topographic map 1:10 000, sheet Klementowice (1984), B – on the raised-relief map (DEM) of the western part of the Nałęczów Plateau “Land of Gullies” developed by B. Hołub et al. (2006), C – in an aerial photograph (2004)

The study object is a small field road gully dissecting the slope of a small valley, constituting the upper section of an erosional-denudational valley (Fig. 1A). The small valley slope, with a denivelation of approximately 10 m and mean inclination of approximately 5°, is exposed to the south. The study object is located in a loess catchment of a gully system in Kolonia Celejów, located in the western part of the Nałęczów Plateau (Fig. 1B). Its geographical coordinates are as follows: 51°20'41" N and 22°6'19" E. The gully is adjacent to arable fields with a width of 15–20 m, with a cross-slope orientation, perpendicular to the edge of the gully (Fig. 1C). The crops include cereals, root vegetables, and berries. The fields are separated with balks on which agricultural scarps developed, with varied heights not exceeding 1 m.

The change of traction from horse-powered to tractors by particular field owners was not synchronic. Mechanisation concerned the Karmanowice village earlier than the poorer farms in Kolonia Celejów located over the gully (S. Furdal and P. Rogoza 2005 – oral information). On the western side, an erosional-accumulative scarp started developing, separating fields from the road. It developed through downwearing of the road surface, but also through the aggradation of the edges with agricultural colluvia accumulated on the slope of the former trough. In 1984, the scarp still did not reach a height of 1 m. It is not marked in the topographic map from that year (Fig. 1A).

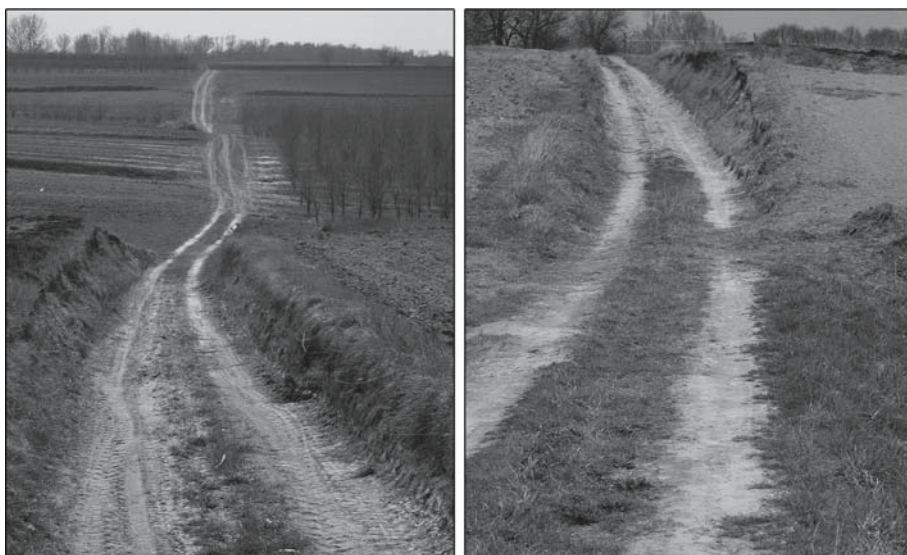
Fig. 3. View of the gully from above and from below in April 2004 (Photo W. Zgłobicki)

Over the period of at least several years, an asymmetric road landform developed, with a low scarp on one side (E), and a relatively gentle trough slope on the other (W), on which transport of material from the field to the road occurred. The road surface was therefore inclined towards the scarp. This resulted in its undercutting and retreat, leading to the migration of the road by 2–3 m to the east (Fig. 2A, B), and the asymmetry of the modern gully (Fig. 3, 5).
